Manhole Inspection Summary

Manhole # S23K__017MH

Insp Date: **6/11/08 9:20 AM**

Location Address: **351 side Ramsey St**

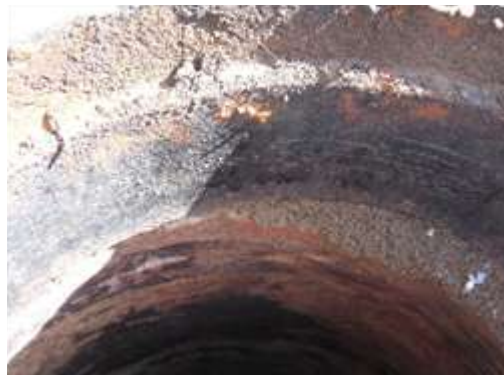
Defect 5

infiltration at chimney frame-lid connect

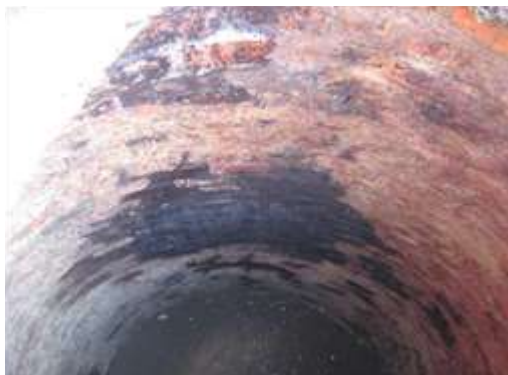
Defect 4

Infiltration: ☐ None ☐ Joint ☐ Cracks ☒ **Mortar** ☐ Roots ☒ **Wall**

signs of infiltration at corbel area

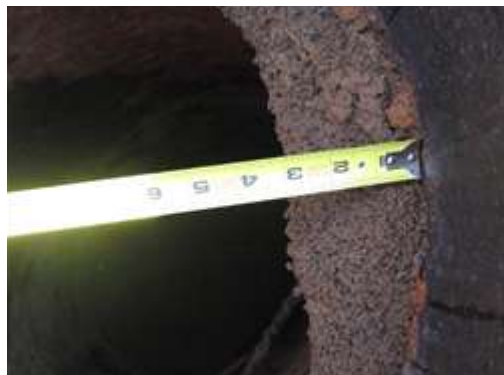
Defect 6

Offset: **3.** (in.)
25

3.25" frame offset

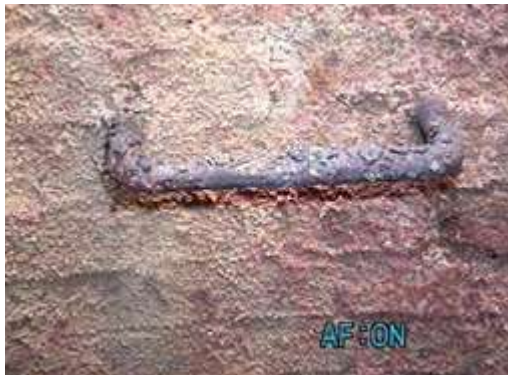
Defect 3

Count: **4** Missing: **0** ☒ **Corroded**

oxidized rungs

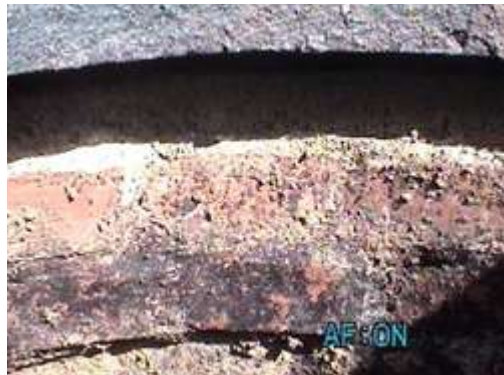
Defect 2

Infiltration: ☐ None ☒ **Joint** ☐ Cracks ☒ **Mortar** ☐ Roots ☐ Wall

infiltration from chimney-frame joint connect

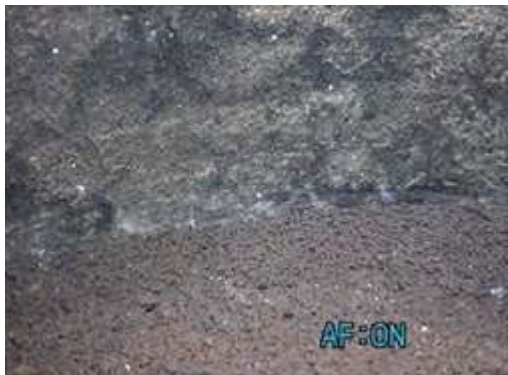
Defect 1

Condition: ☐ Sound ☐ Cracked ☐ Root Intrusion ☐ Deteriorated ☐ Leaks ☒ **Debris**

debris on bench and channel

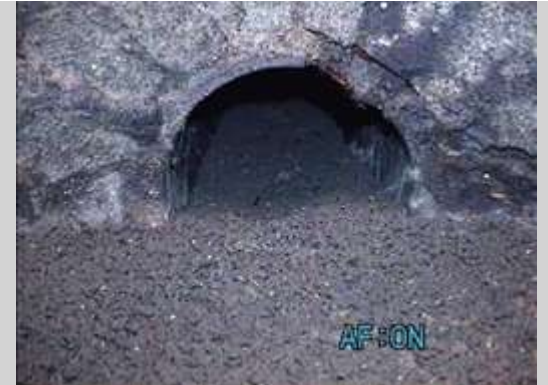
12 O'Clock Outflow

8 in. Circular Gravity Sewer
Pipe Out @ 12 O'Clock

Deposits: ☐ None ☐ Mud ☐ Sludge ☒ **Debris** ☐ Grease

Silt Depth: **4.5** (in.) Deposits Extent: **Heavy**
